October 2015

Water Heater Connector Failures: An Engineering Assessment of Cause

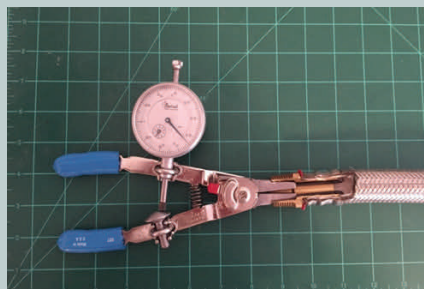
Custom made durometer and cross sectioned exemplar connector

using a high end articulating borescope to document the failure region.

An exemplar connector was cross sectioned to understand the interior make up of the hose and to assist in the design and manufacture of a custom made durometer that could perform the task of measuring the hardness of the plastic interior materials. The durometer was first tested in an exemplar connector. Then, each reportedly failed hose was visually inspected on the exterior and in the interior. They were also measured and photographed both externally and internally to document what was present in and on the hose upon receipt. The location and cause of the leak was observed and then photographed internally

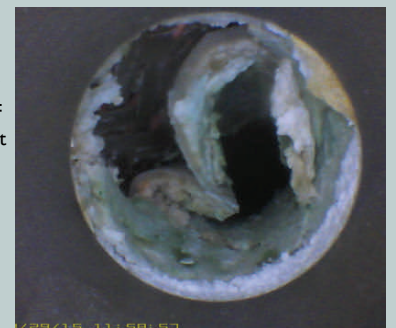
Internal borescope image revealing the decomposition of the interior plastic tubing.

After analyzing multiple connectors of differing sizes, most being 12, 18 and 24 inches in length with 3/4 inch female fittings on either end, the findings were consistent. The leaks, as many online had speculated, were not related to the fittings. **U.S. Forensic, through their testing, revealed that the leaks were present within the inner plastic tubes and were the result of the inner plastic tubes prematurely decomposing and flaking apart. This material defect led to a breach of the internal wall which caused the water release and the resultant damages at the various properties across the country.**

This manufacturing or design defect in many cases ultimately caused the braided stainless steel housing of the connectors to cave in, deform, and/or twist. It was determined that a chemical reaction caused the plastic tubing in the connectors to decompose, and this decomposition caused the connector to structurally deform. Additional information regarding the materials used and the manufacturing process received will provide insight as to the chemical process involved in the decomposing process and the root cause of the defective product.
